Manhole Inspection Summary

Manhole # S47EE_002MH

Insp Date: 7/21/08 9:15 AM

Location Address: **Patterson Park**

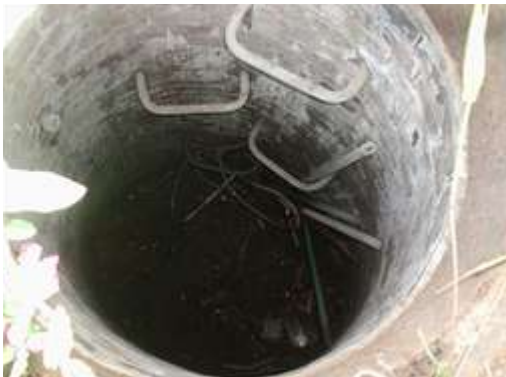
Defect 1

Infiltration: ☐ None ☐ Joint ☐ Cracks ☐ Mortar ☐ Roots ☒ **Wall**

Infiltration

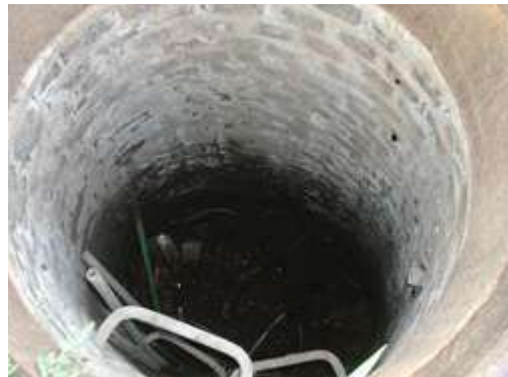
Defect 2

☒ **Leaks**

Frame leaks

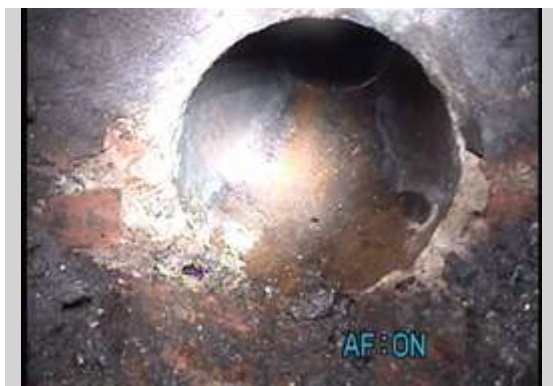
12 O'Clock Outflow

8 in. Circular Gravity Sewer
Pipe Out @ 12 O'Clock

Infiltration: **None** Pipe Seal Cond: **Sound**
